AFRPL-TR-66-350

156-INCH DIAMETER MARAGING STEEL CASE  
HYDROBURST AND MATERIALS EVALUATION

TECHNICAL REPORT NO. AFRPL-TR-66-350

J. S. Coverdale,  
Norbert Wells,  
Gilbert Skopp  
George Brocker

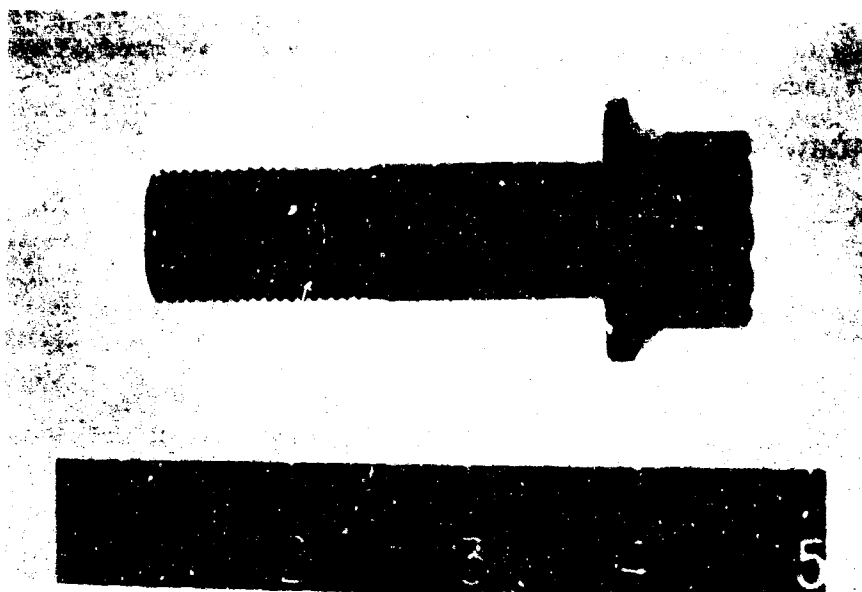
Figure 21 Thread Damage Found on Many of the Bolts
